Powerplant failure or malfunction [SCF-PP]  
Airbus model 320-271N, serial number 8894, registration XA-VIO  
Operated by Viva Aerobus, S. A. de C. V.  
Commercial air transport, revenue operations, passenger flight  
Guadalajara International Airport "MMGL"  
December 24, 2022, at 01:56 local time [1956 UTC]

## FINAL REPORT

XA-VIO  
INCGDTAFA182/2022MMGL

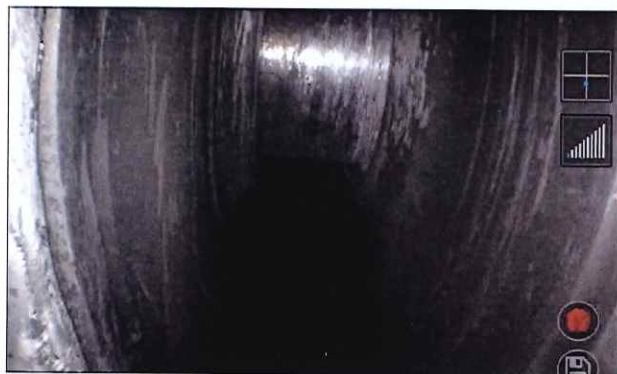
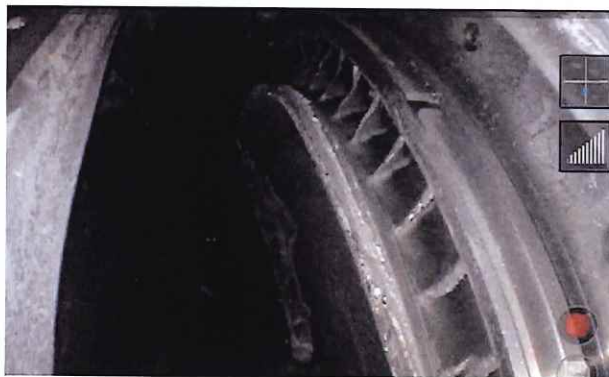
The boroscope inspection found the High Pressure Compressor [HPC] 7th Stage Integrally Bladed Rotor [IBR-7] missing & fractured, due to uncontained engine failure on takeoff roll. as shown on Fig. 1.3.a.

Fig. 1.3.a. High Pressure Compressor [HPC] 7th Stage Integrally Bladed Rotor [IBR-7].

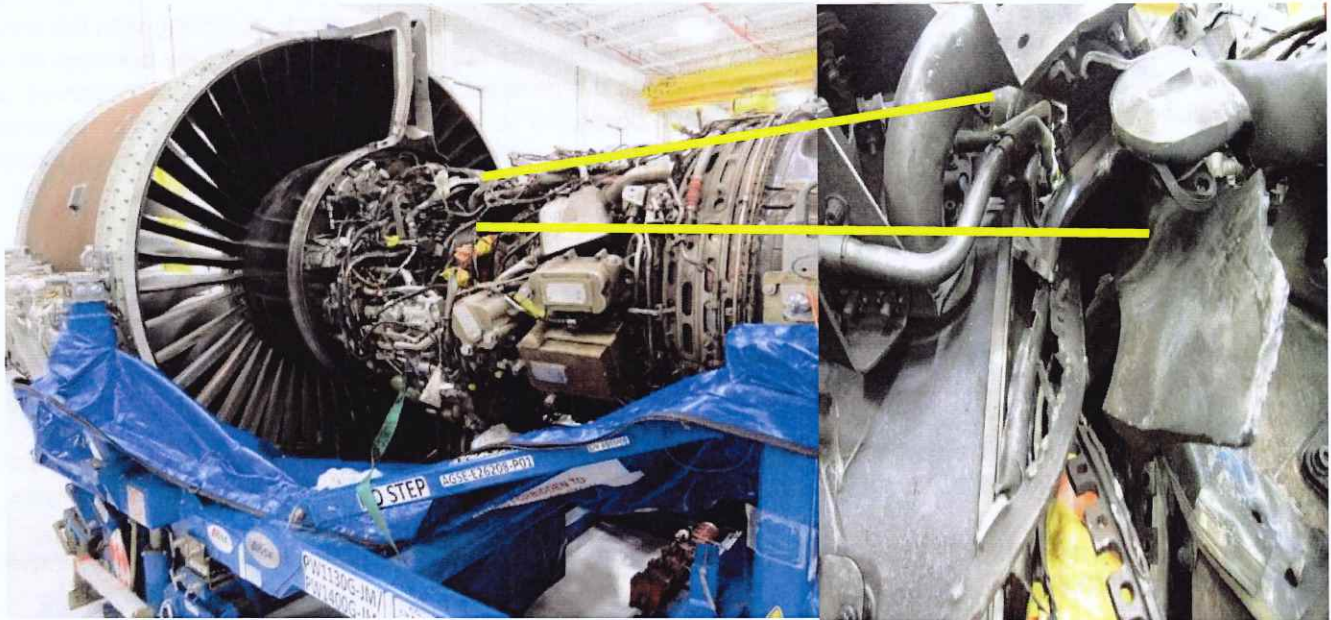
The uncontained engine failure of High Pressure Compressor (HPC) 7th Stage Integrally Bladed Rotor (IBR-7) on engine No. 2, generated a lot of metal debris and two larger fragments labeled as # 1 & # 2. Fragment # 2 remained embedded in the engine as shown on Fig. 1.3b and Fig. 1.16.1.b.

Fig 1.3.b. High Pressure Compressor (HPC) 7th Stage Integrally Bladed Rotor (IBR-7) of engine No. 2, fracture and damage zone for explosion.

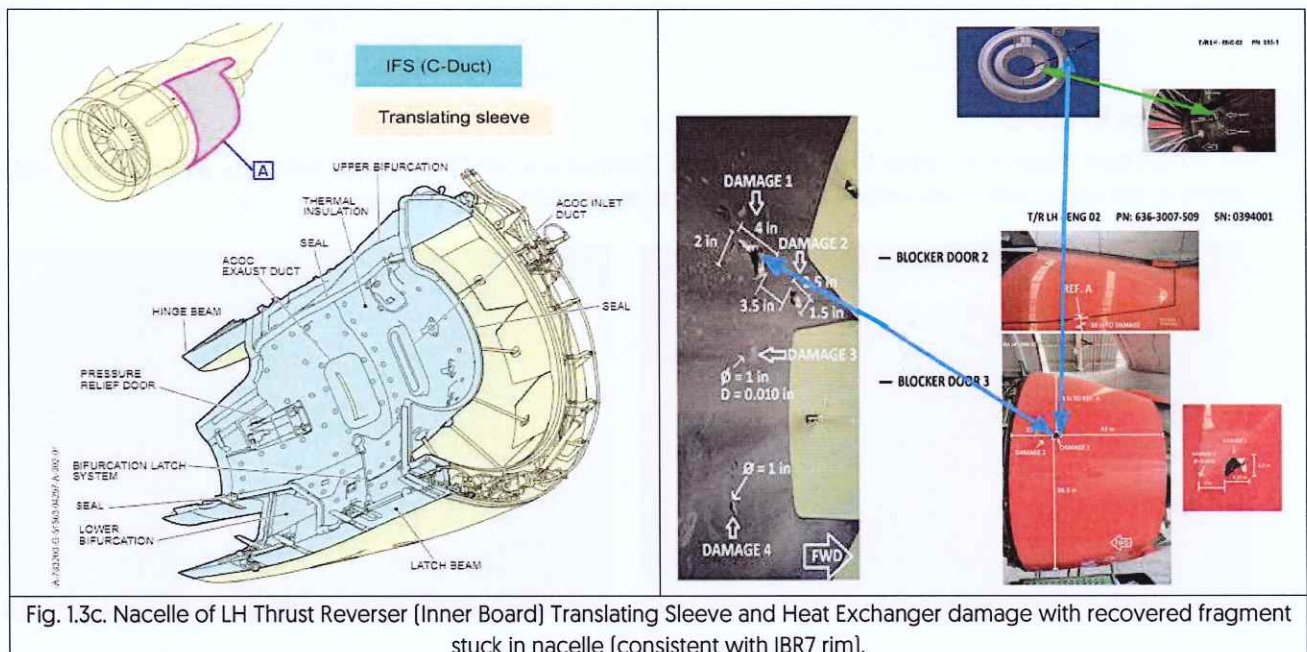
Nacelle of LH Thrust Reverser (Inner board) and the Heat Exchanger with damage that contributed to prevent full uncontainment of the fragment #2. as shown on Fig. 1.3c.

Fig. 1.3c. Nacelle of LH Thrust Reverser (Inner Board) Translating Sleeve and Heat Exchanger damage with recovered fragment stuck in nacelle (consistent with IBR7 rim).

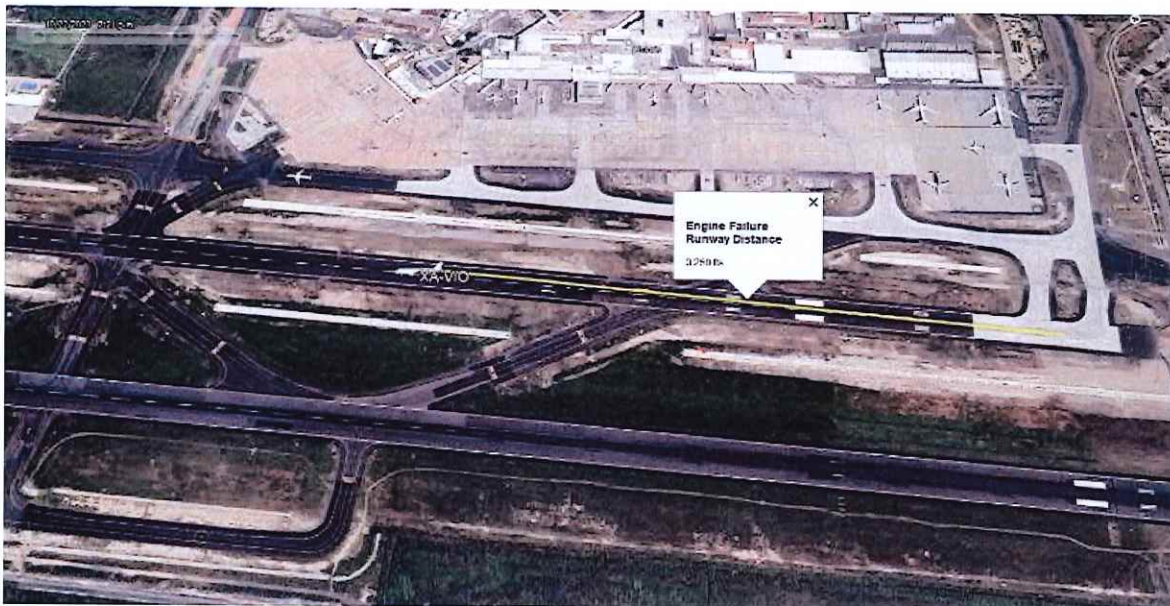
Fig. 1.12.a. Engine Failure Runway Distance 3250 Feet.

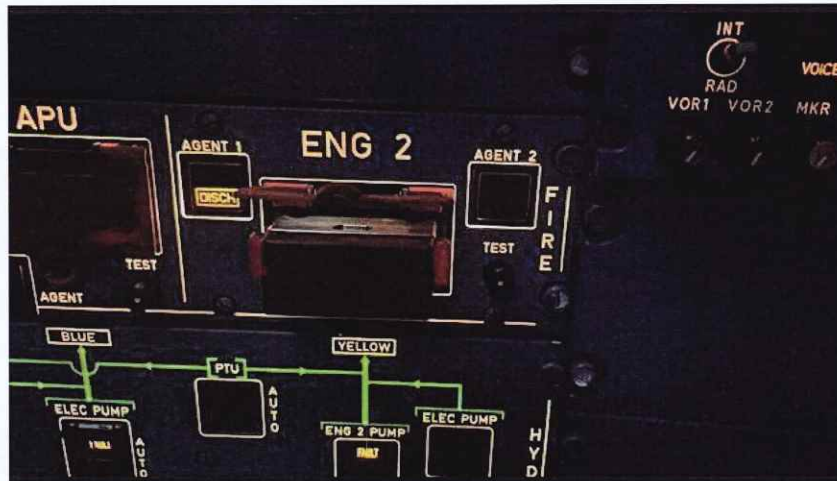
There was presence of fire during takeoff roll due to uncontained engine failure, the No. 2 engine fire suppression bottle that was discharged. The fire was controlled without spreading towards the aircraft.

Fig. 1.14.a. Guard raised and discharged the No. 1 fire bottle on engine No. 2

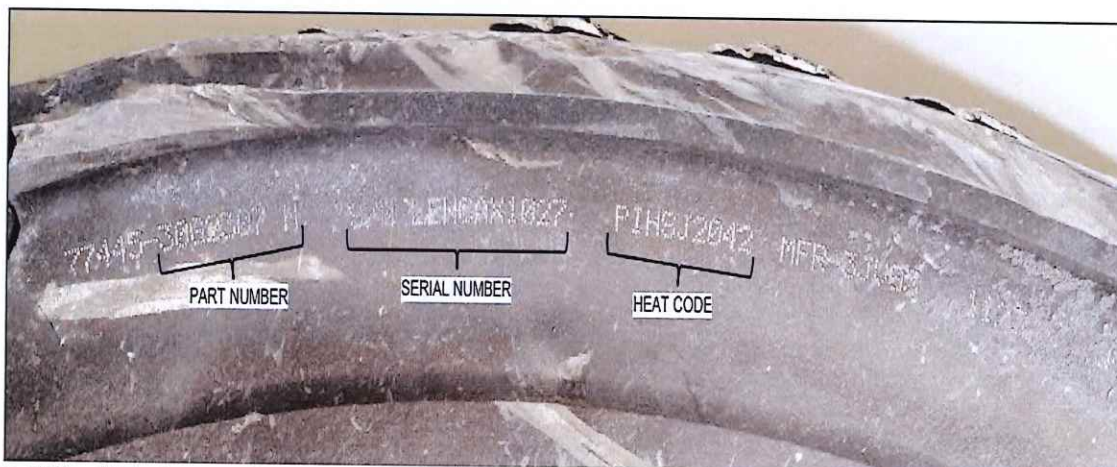
The engine No. 2 was disassembly the evidence shows the HPC 7<sup>th</sup> Stage Integrally Bladed Rotor (IBR-7) fracture, on shop recovered a big fragment identified with (PN: 30G2307 Rev. H, SN: LENCAX1027, heat code PIHSJ2042 and MFR 3JV93) and presence of radially damage from bore to rim in to places spaced 220 degrees apart, all airfoils from the disk showed fractured adjacent to the rim interior to outside diameter, as shown on Fig. 1.16.1.a.

Fig. 1.16.1.a. High Pressure Compressor (HPC) 7<sup>th</sup> Stage Integrally Bladed Rotor (IBR-7) recovered part identification.

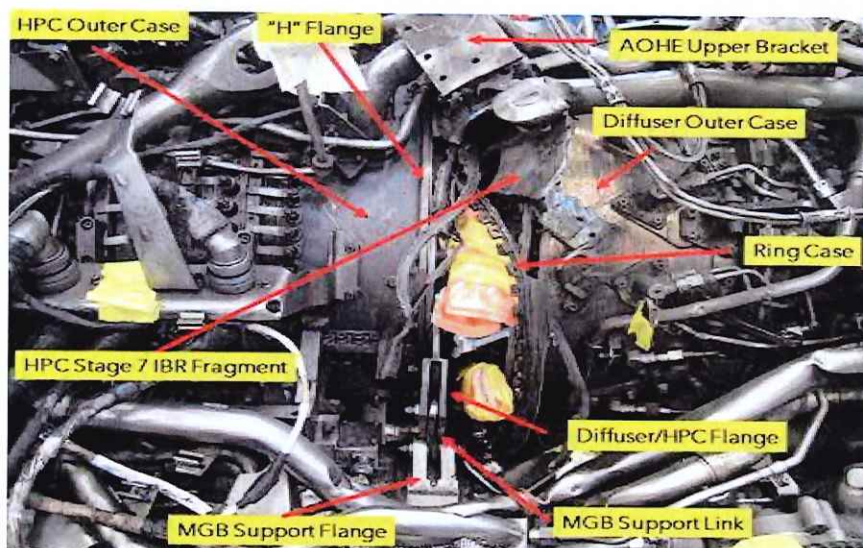
The HPC 7th Stage IBR-7 fracture penetrated on the diffuser outer case, just aft of H flange an exit hole from about the 7:00 to 12:00 o'clock positions damage as. One hole measured approximately 4.5 to 5.0 inches axially by 25 inches circumferentially. Protruding from the hole was a section of the HPC 7th Stage IBR-7 and part of the ring case attachment flange.

The hardware in the vicinity of the diffuser outer case hole exhibited torn, cut and fractured tubes, lines and brackets; dented, twisted and displaced case material, thermally distressed, frayed and cut electrical wires and impact damaged accessories. Light sooting/oil residues were observed on the left side of the engine forward of the H flange to the firewall. The main gearbox (MGB) support flange and the support link, located on the left side of the engine, was intact and present but was distorted and twisted. as shown on Fig. 1.16.1.b.

Fig. 1.16.1.b. Exit Hole in the Diffuser Outer Case with Collateral Damages

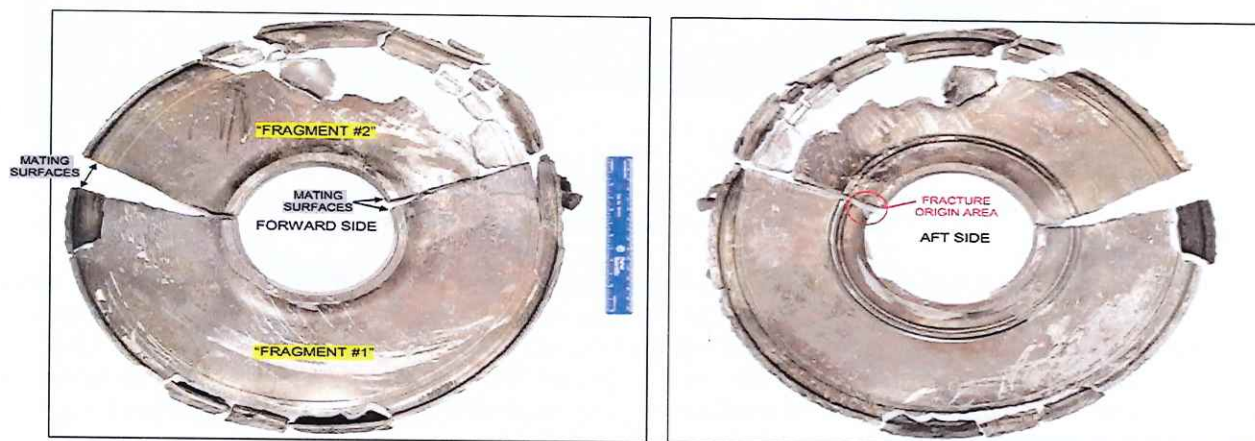
Overall views of fragments arranged together with mating fragments fit into place, when possible, both sides. All fragments exhibited extensive event-related damage, some thermal discoloration, and varying amounts of adhered debris on surfaces. Several portions of the web and a rim fragment appeared to be missing. All airfoils had fractured adjacent to the rim [OD] outside diameter and were missing. The IBR No. 7 had fractured radially from bore to rim in two places spaced ~220 degrees apart. The two larger recovered IBR No.7 fragments containing the mating halves of both radial fractures were arbitrarily labeled #1 and #2 for investigation purposes as shown on Fig. 1.16.3.1.a.

1.16.3.1.a. Overall views of fragments and fracture radially from bore to rim in two places spaced ~220 degrees apart.

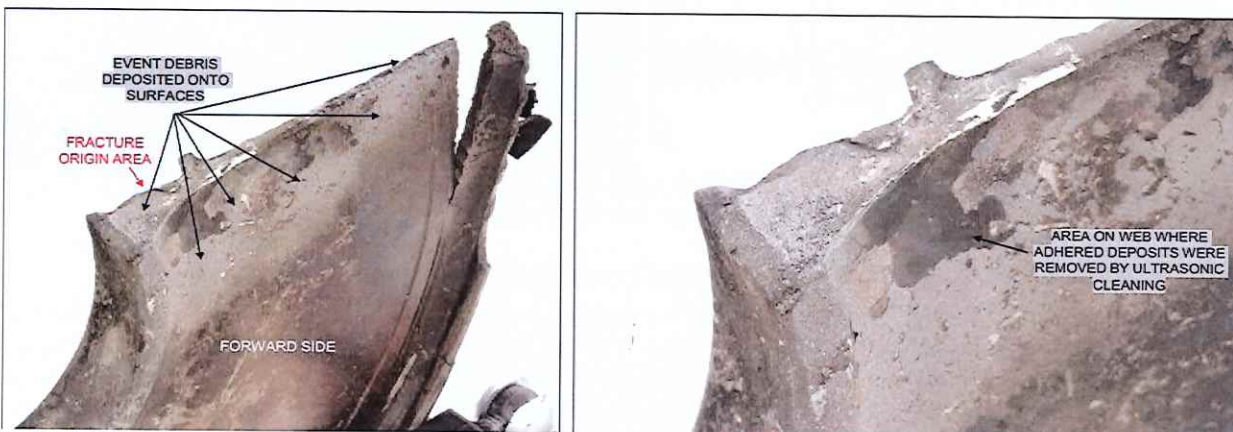
Primary fracture on fragment #1 surface showing a thick layer [cladding] of adhered event debris deposits on the forward web/bore surfaces adjacent to the fracture. Portions of the fracture surface were also covered in this debris, which obscured fracture features, including the origin area. The debris had a matte grey metallized appearance, as shown on Fig. 1.16.3.2.a.

Fig. 1.16.3.2.a. Fragment #1 surface showing a thick layer [cladding] of adhered event debris deposits on the forward web/bore surfaces adjacent to the fracture.

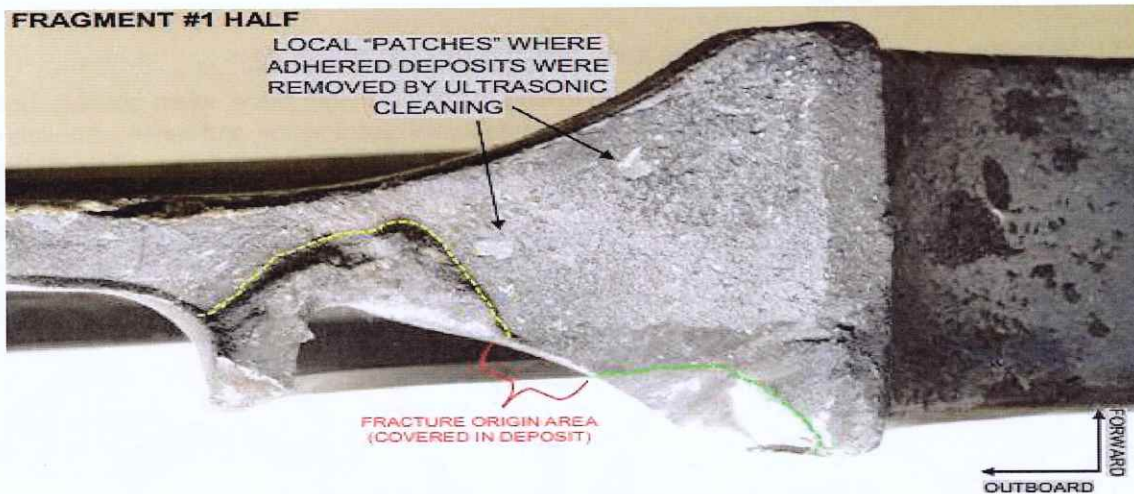
Close-up view of fragment #1 fracture halves at bore region. Area denoted by yellow dashed line was observed on fragment fracture half, as a heavily damaged positive (proud) feature on fragment #1, indicating the surfaces mated. Areas denoted by green dashed lines were negative features on both fracture halves (not mating, i.e. piece(s) missing), as shown on Fig. 1.16.3.2.b.

Fig. 1.16.3.2.b. Fragment #1 fracture half at bore region.

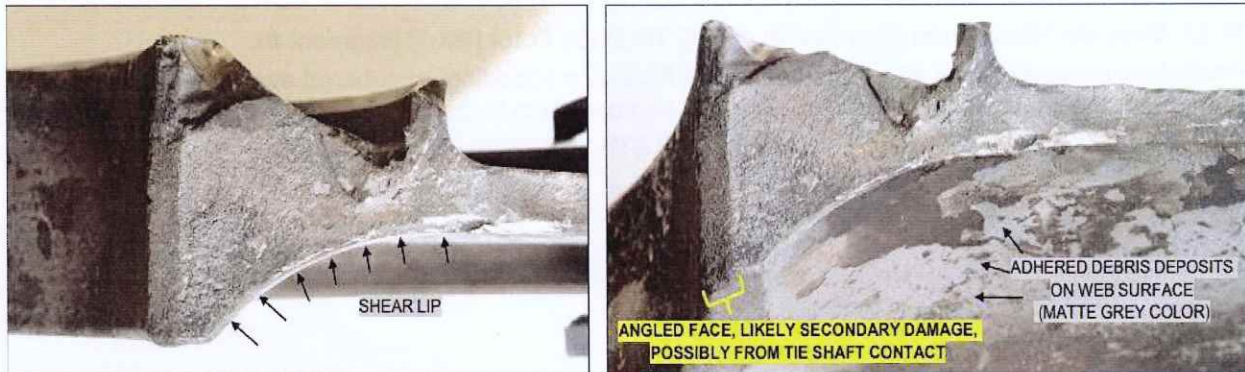
On fragment #1 primary radial fracture surface, which was covered in a layer of debris that obscured fracture features. Certain features on the surface were still identifiable such as a small, continuous shear lip along the forward edge of the bore fracture and an angled surface plane along the bore "ID" inside diameter that was considered most likely secondary damage, possibly from contact with the HPC tie shaft immediately following fracture, the deposit layer had been locally removed from two small areas on the bore region of the fracture surface fragment # 1 during an initial ultrasonic cleaning, as show on Fig. 1.16.3.2.c.

Fig. 1.16.3.2.c. Fragment #1 primary radial fracture surface was covered in a layer of debris that obscured fracture & angled face likely secondary damage.

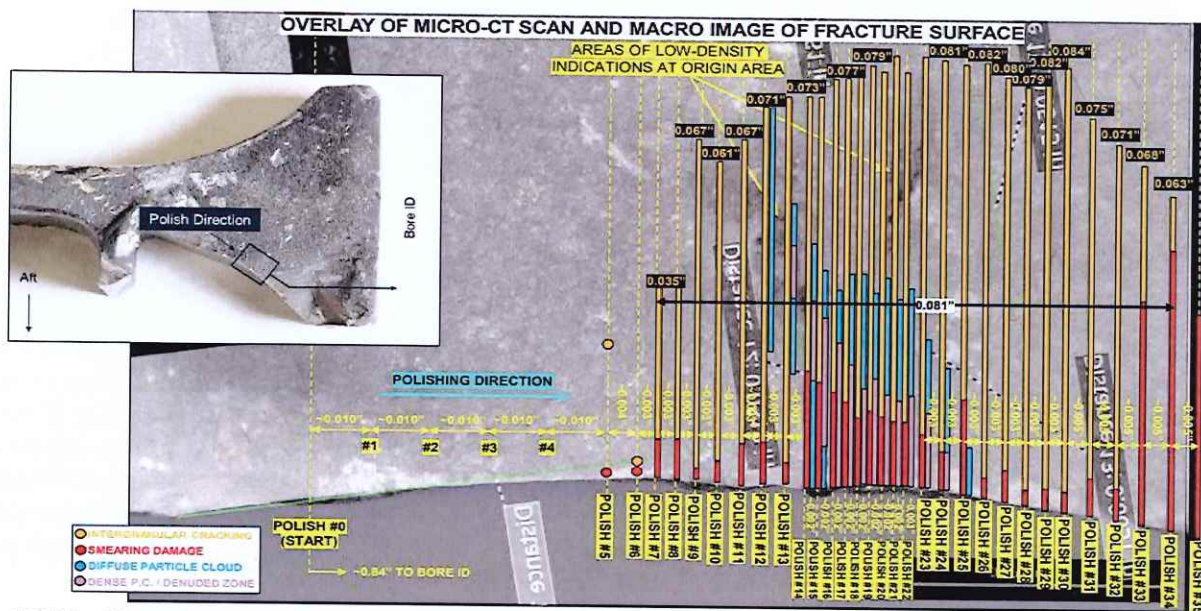
A transverse metallographic section was prepared through the fragment #1 fracture half ~0.84" radially outboard of the bore ID and serial polished in the inboard direction through the fatigue origin area. The section was mounted in clear epoxy resin so that progress serial of 35 polishing sections could be visually observed. Caliper measurements were used to ensure the targeted amount of material was removed at each polishing step. The known positions of smearing damage relative to the low-density indication areas found in the [micro-CT scans] scans micro computed tomography of the fragment #1 fracture half was used as guides for targeting the origin area during serial polishing

since the area was completely obscured by debris deposits. The section was reviewed at each polishing step in both the as-polished [unetched] and etched conditions for the presence of any intergranular cracking and any evidence of a [NMI] Non-Metallic Inclusions [particle cloud]. The dimensions of these features, including their distance from the aft bore face, were measured when present. The extent of secondary smearing damage on the fracture surface along the aft bore face was also measured when present. At select polishes, the angle of the intergranular crack zone relative to the plane of transgranular fatigue progression was estimated. The following map summarizing the results of the serial polishing and the types of damage as Intergranular Cracking, Smearing Damage, Diffuse Particle Cloud, Dense P.C. Particle Cloud & Gamma Prime Denuded Zone, as shown on Fig. 1.16.3.3.a.

Fig. 1.16.3.3.a. Map summarizing results damage of a serial polishing through the origin area on the HPC 7<sup>th</sup> Stage Rotor [IBR-7] fragment #1 fracture half.

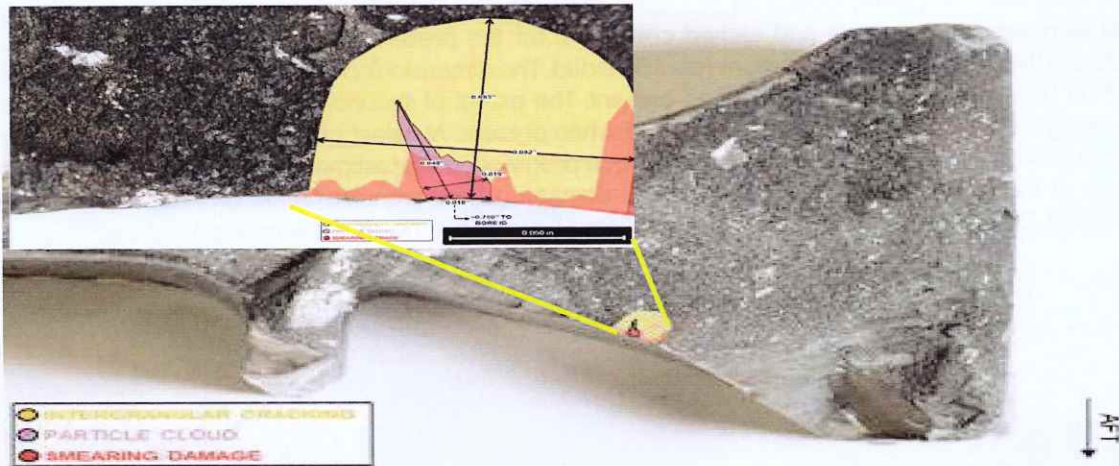
The serial polishing summary map shown on Fig. 1.16.3.4.a was refined to estimate the size and shape of both the intergranular crack zone and the particle cloud, and the extent of smearing damage on the fracture surface. A graphical representation of the intergranular crack zone, particle cloud and smearing damage was overlaid [to scale] onto macro images of the fragment #1 fracture half. As previously mentioned, the smearing damage prevented conclusive determination as to how much of the intergranular crack zone had been connected to the aft bore surface. However, based on previous evaluations of intergranular crack zones associated with particle clouds compared with the size/shape and orientation of each in the subject HPC 7th Stage Rotor [IBR-7], it was considered reasonable to conclude that both the particle cloud and the intergranular crack zone had intersected the aft bore surface and some portions of each had been machined away at manufacture. The remaining portion of the particle cloud measured ~0.018" long at the aft bore surface and up to ~0.048" deep from the surface. The remaining portion of the intergranular crack region measured up to ~0.092" wide by 0.083" deep from the aft bore surface. The distance from the center of the particle cloud to the bore [ID] Inside Diameter measured ~0.750", as shown on Fig. 1.16.3.4.a.

Fig. 1.16.3.4.a. Intergranular Crack surface length in Lab at P&W the OEM measured ~0.092" wide by 0.083" deep from the aft bore surface, the particle cloud measured ~0.018" long at the aft bore surface and up to ~0.048" deep from the surface and the distance from the center of the particle cloud to the bore (ID) Inside Diameter measured ~0.750".

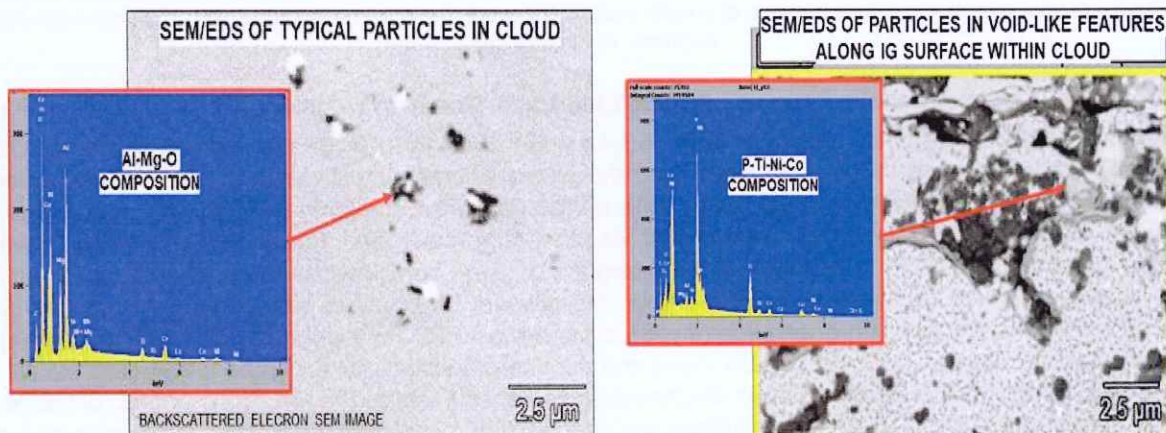
Carried out the Electron microprobe [EMP] analysis of the particle cloud at polish #14 on the fragment # 1 revealed particles with material of [Al-Mg-O and Al-O] Aluminum-Magnesium-Oxygen type particles with isolated [P-Ti-Ni-Co] Phosphorus, Titanium, Nickel- Cobalt particles with a higher concentration of [SI] silicon and No significant [P] Phosphorous concentrations were observed within the reacted zone; the particle cloud chemistry of P771325 HPC Stage Rotor IBR No. 7th fractured origin areas, these were similar on P&W previous examination of cracking in powder metal nickel alloy has identified particle cloud type nonmetallic inclusions [NMIs] and associated intergranular processing cracking at crack origin areas, as shown on Fig. 1.16.3.5.a.

Fig. 1.16.3.5.a. [EMP] Electron Microprobe Analysis of Particle Cloud Chemistry at polish #14. With particles material of Al-Mg-O and Al-O.

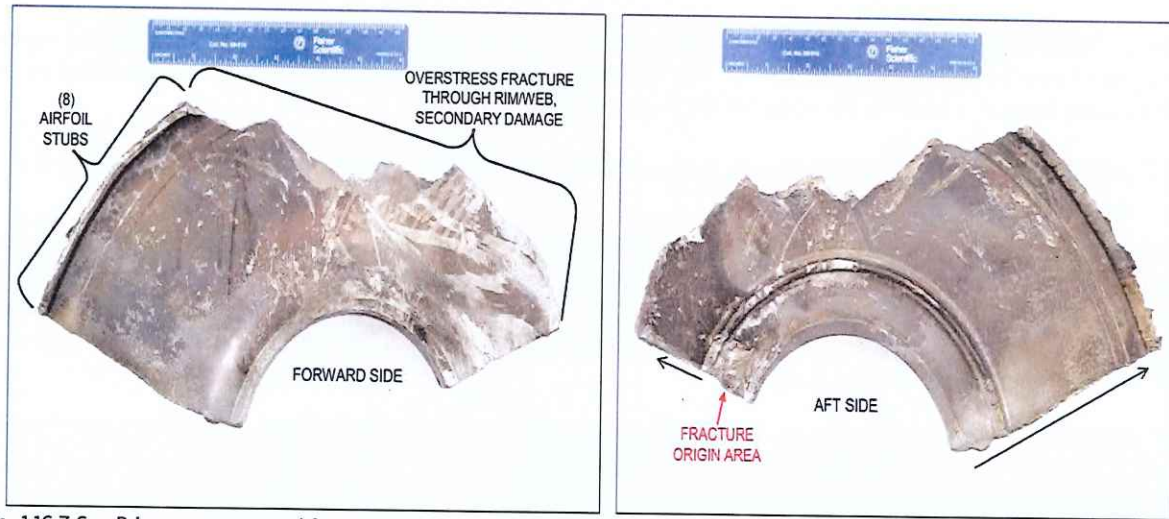
The suspected primary fracture origin area on a planar region of fracture was observed in the bore area on one of the two radial fractures on the fragment # 2 on this exhibited overstress features through the web with directionality towards the rim from the bore area, as shown on Fig. 1.16.3.6.a.

Fig. 1.16.3.6.a. Primary suspected fracture origin area on a planar region with overstress features through the rim/web with extensive secondary smearing damage.

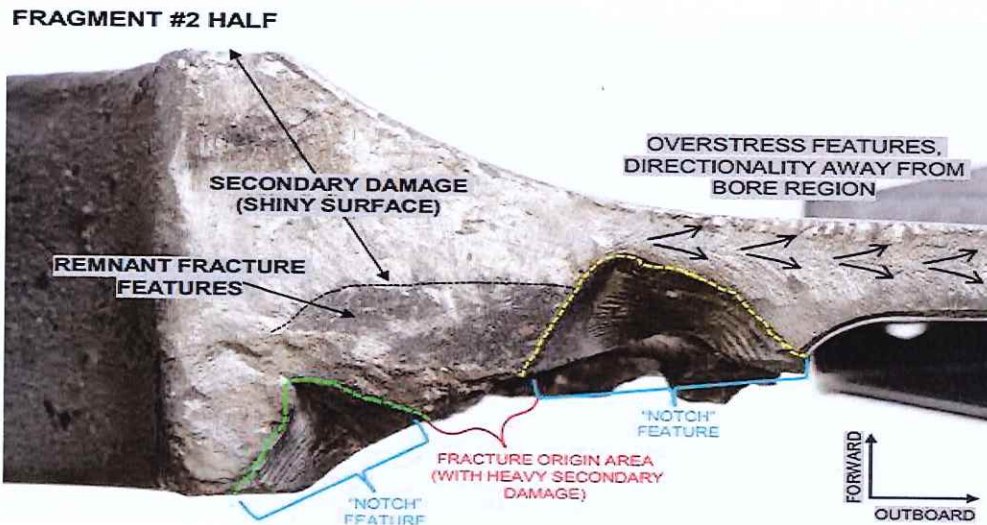
Close-up view of fragment #2 fracture halves at bore region. The area denoted by yellow dashed line was observed on fragment fracture half, as a negative feature on fragment #2, indicating the surfaces mated. Areas denoted by green dashed lines were negative features on both fracture halves [not mating, i.e. piece(s) missing,] as shown on Fig. 1.16.3.6.b.

Fig. 1.16.3.6.b. Fragment #2 fracture half at bore region

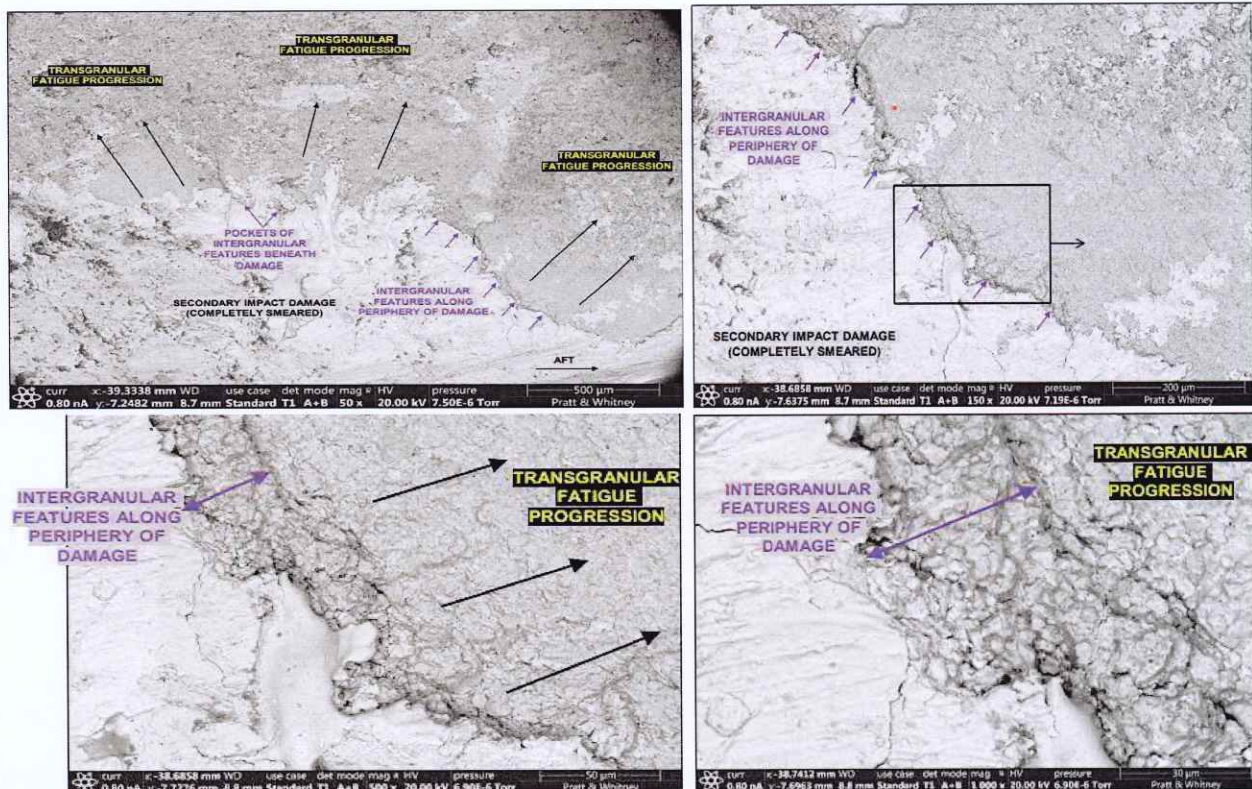
On SEM examination of the HPC 7<sup>th</sup> Stage Rotor (IBR-7) fragment #2 fracture origin area intergranular features in isolated pockets within the secondary impact damage zone and along the periphery of the damage on the aft side of the origin area. A sharp transition from these intergranular features to transgranular fatigue progression was observed. Both transgranular and intergranular features appeared oxidized. No evidence of overstress was observed at the transition, as shown on Fig. 1.16.3.7.a.

Fig. 1.16.3.7.a. Scanning Electron Microscopy examination of the HPC 7<sup>th</sup> Stage Rotor (IBR-7) fragment #2 revealed intergranular features to transgranular fatigue

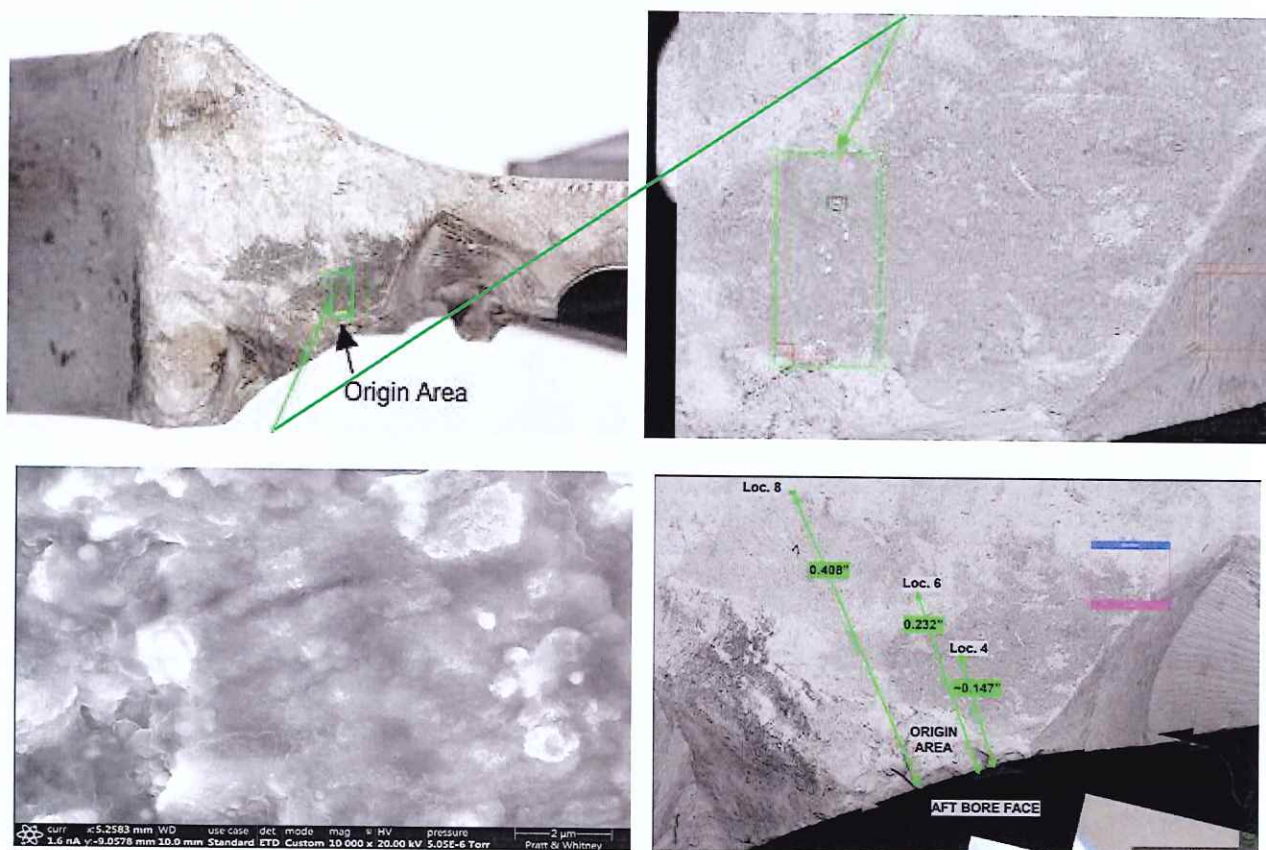
Patches of heavily oxidized [obscured] and poorly resolvable fatigue striations typical of low cycle fatigue (LCF) were occasionally observed in between areas of secondary smearing and surface deposits throughout the transgranular fatigue progression. A striation counts to estimate the number of LCF crack propagation cycles was not possible. Attempts to remove the oxide scale from the surface with iterative cleanings in an Alconox detergent solution [200°F / 10 – 30 min.] to provide limited striation spacing data for a crack growth rate assessment were unsuccessful.

Continued examination of pockets of intact fracture features found a gradual transition from stable fatigue crack growth to unstable/cyclic tearing up to 0.408" from the aft bore face, beyond which crack surface features were completely removed by secondary smearing damage. It was not possible to identify the transition to entirely overstress features, representing the crack extremity, due to the damage on the fracture surface. Evidence of ductile dimple features were first observed ~0.147" from the aft bore face. Secondary cracking/tearing and >50% ductile

simple features indicative of unstable crack growth were observed  $\sim 0.232''$  from the aft bore face and beyond, as show on Fig. 1.16.3.7.b.

Fig. 1.16.3.7.b. Patches of heavily oxidized [obscured] fatigue striations typical of low cycle fatigue (LCF) observed in between areas of secondary smearing and surface deposits throughout the transgranular fatigue progression.

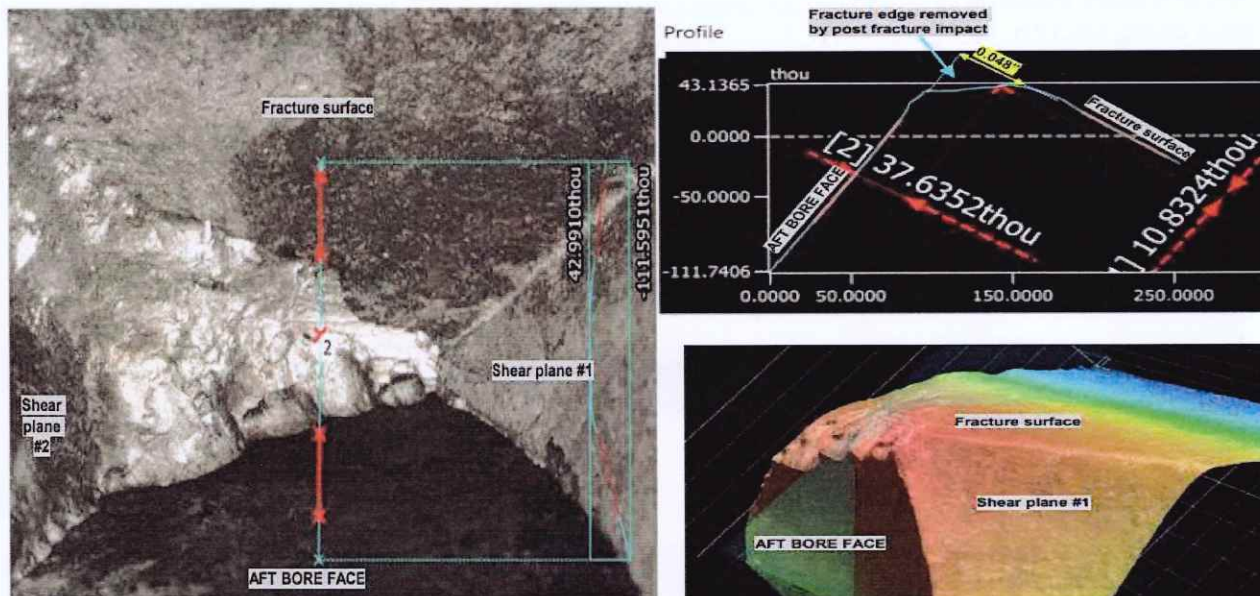
Keyence 3D light interferometer profile scan was carried out on the fragment #2 fracture half at the fatigue origin area to assess how much material was removed by the secondary impact damage, based on the known depth of the particle cloud from the aft bore face (up to  $\sim 0.048''$  deep) determined by serial polishing of fragment #1, a large amount of the particle cloud on the fragment #2 half was expected to have been removed.

A portion of the fragment #2 fracture surface containing the origin area was sectioned off via wire [EDM] electrical discharge machining to facilitate micro computed tomography (micro-CT) scanning. The piece measured  $0.100''$  thick to allow for optimal scan spatial resolution ( $\sim 6\mu\text{m}$  pixel resolution). No clear low-density indications were found in the scan, as shown on Fig. 1.16.3.8.a.

Fig. 1.16.3.8.a. A Keyence 3D light interferometer profile scan was carried out on the fragment #2 fracture half at the fatigue origin area to assess how much material was removed by the secondary impact damage, based on the known depth of the particle cloud from the aft bore face (up to ~0.048" deep).

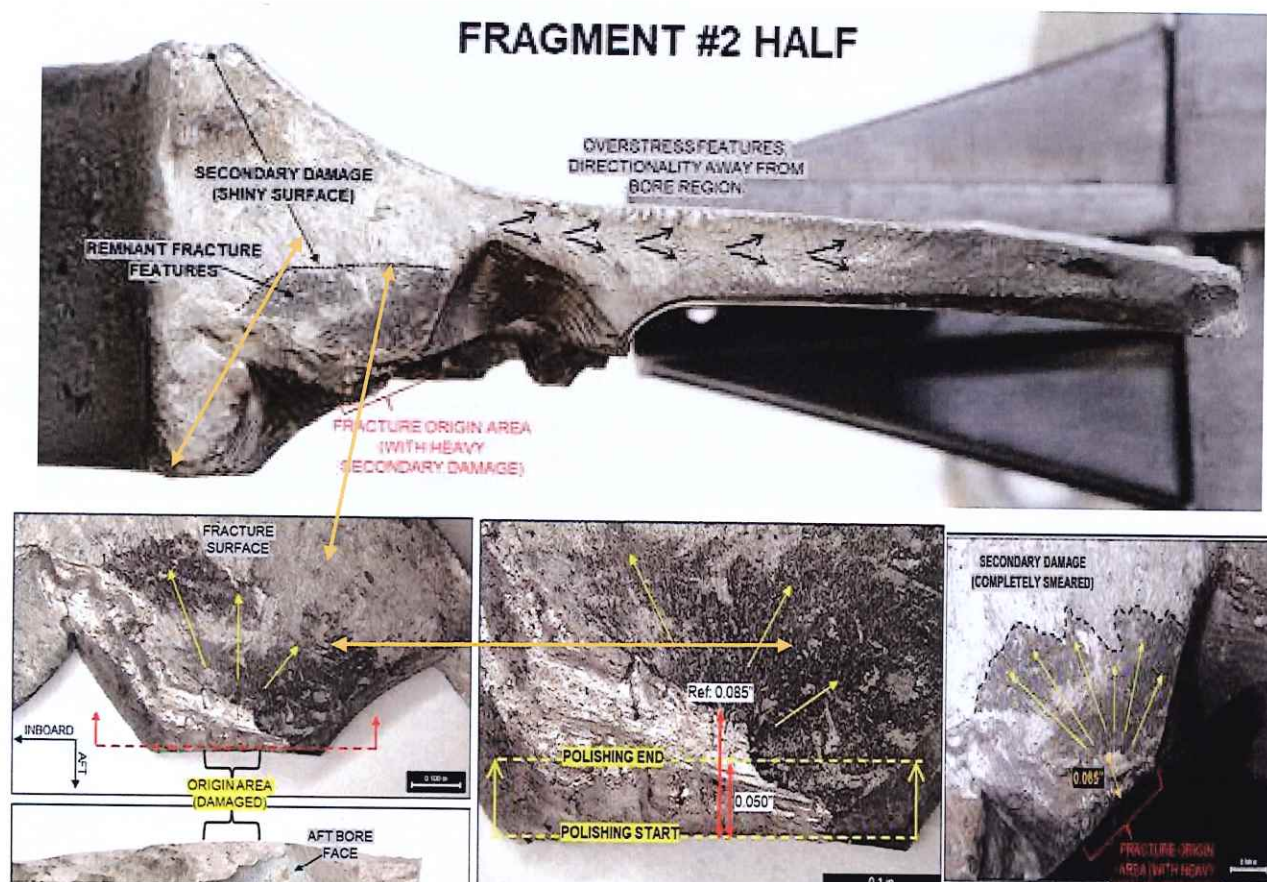
Decided to serial polish through the fatigue origin area on the fragment #2 half primarily to acquire any additional dimensional information regarding the intergranular zone and particle cloud. A transverse metallographic section was prepared through the origin area by mounting the aft bore face of the piece down in clear epoxy resin and grinding through the curvature of the aft bore face until the section was plane, which placed the starting polish plane [polish #0] ~0.018" from the aft bore face. Examination of the section at polish #0 revealed a small area of diffuse particle cloud in line with the approximate origin up to ~0.028" deep beneath the estimated original fracture plane. No dense particle cloud/gamma prime denuded zone was observed.

The section was serial polished in 0.005" increments up to a depth of 0.048" from the aft bore face, resulting in six (6) polishes. Caliper measurements were used to ensure the targeted amount of material was removed at each polishing step. Over the course of these polishes, the small area of diffuse particle cloud was consistently observed and generally diminished in size/depth from the estimated original fracture plane. The only evidence of dense particle cloud / gamma prime denuded zone was observed in polish #2. The zone was contained within the diffuse cloud and measured ~0.003" wide by <0.001" deep. The actual size/shape of this zone was affected by microstructural smearing damage. Intergranular cracking up to 0.002" deep from the damaged surface was noted in polish #4. Polishes #5 and #6 intersected the region of intergranular crack surface previously found along the aft edge of the damage zone during SEM examination. Since the known depth of the particle cloud on the fragment #1 half had already been reached (0.048"), no further serial polishing through the origin area was carried out. Serial polishing confirmed that most of the intergranular zone and particle cloud on fragment #2 had been removed by the secondary impact damage, as shown on Fig. 1.16.3.9.a.

Fig. 1.16.3.9.a. Fragment #2 with six polishing on the fatigue origin area half primarily carried out, confirmed that most of the intergranular zone and particle cloud had been removed to detect the secondary impact damage.
